# The 2006 and 2007 seasons at Ramat Rahel

#### Introduction

This preliminary report presents the results of three excavation seasons conducted at Ramat Rahel between May 2006 and September 2007.<sup>1</sup> The first of the three seasons was financed by The Israel National Fund and the Israel ministry of tourism and was dedicated to the excavation of the south-eastern corner of the site (areas D2).<sup>2</sup> This short preliminary season was quickly followed by a four weeks excavation season in which an average of 60 team members from Germany, USA and other countries took part. Four areas were excavated: areas D1, C1 and C2 (excavated already in 2005) and area D3.<sup>3</sup> The third season was held in August 2007, when we continued excavating areas D1, C1 and C2, and began excavating in area D4.<sup>4</sup>

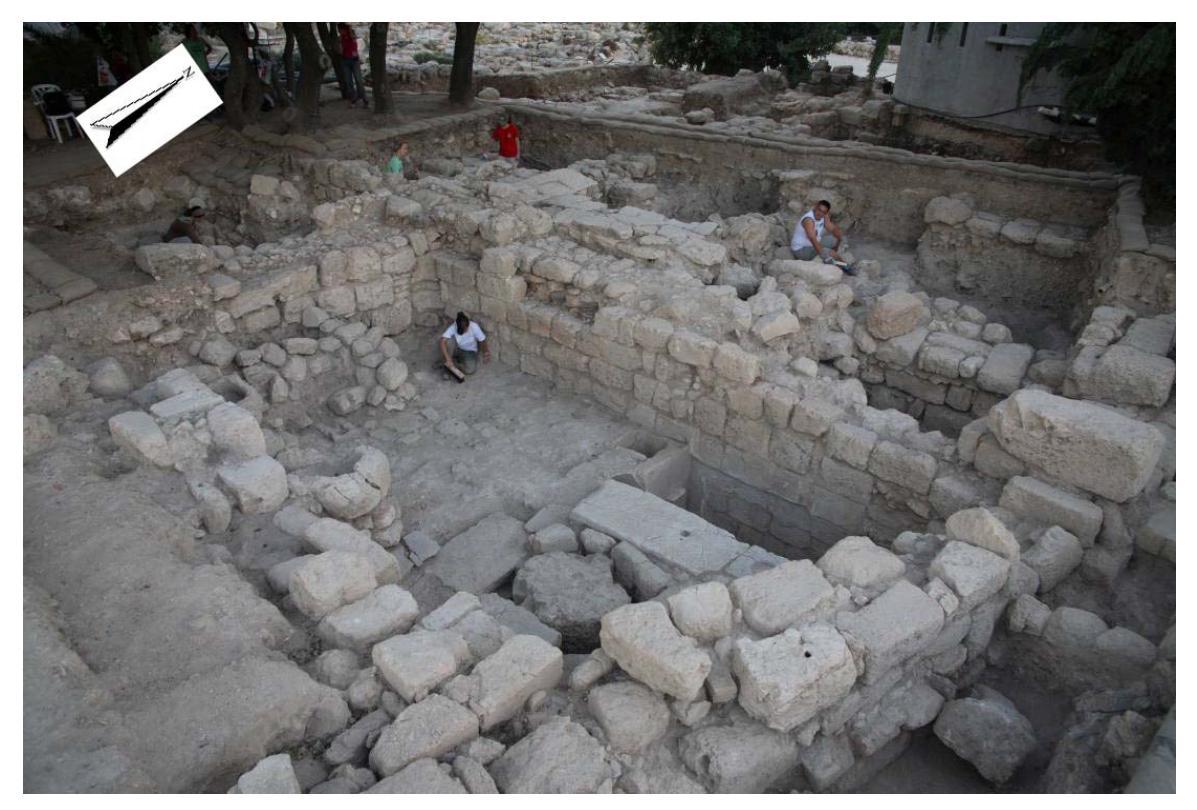
Fig. 2 – Area D1 (2007)

The earliest features in area D1 are two walls dating to the Iron Age (phase D1-6). As the exposure is very limited at the moment, it is impossible evaluate the overall plan and the exact date of these features.

D1-4). The vat's floor is mostly flat and made of plaster except for a small rounded depression covered by a mosaic floor located at the eastern end of the vat.

The installation was attached to a well built wall to the north of it. This wall must have served as a terrace wall and was built in an earlier stage not yet defined by more finds, and continued to exist in the next phase (see below). Similar installations were found by Aharoni in the area to the west of our Area D2 (see Aharoni 1964: 16) and under the floor of the church (see area D4 below). The installations date to the Byzantine period.

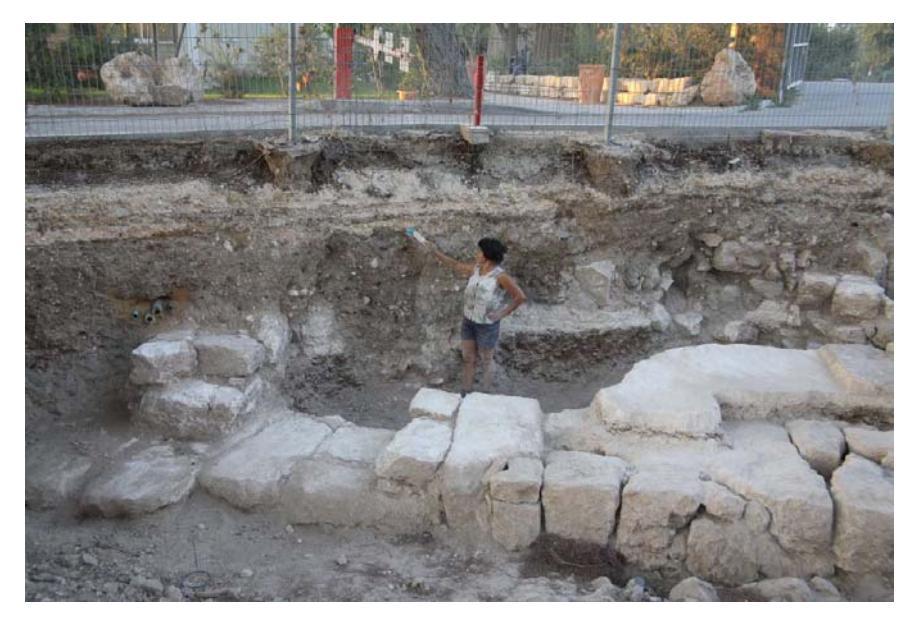
Fig. 4 - The Iron Age wall in Area D2

The earliest find in this area is a defense wall dating to the Iron Age (D2-5), the eastward continuation of Aharoni's casemate wall of Stratum VB (Aharoni 1964: Fig. 6, squares M/L-20/23).

The wall is built directly on the natural rock (combination of flint and chalk), which slopes from north-east to south-west. We were able to trace the foundation trench which follows the north face of the wall. The trench cuts into the rock. Above the trench, a floor made by a thin layer of white crushed chalk, approached to the wall and sealed the earth fill of the trench. The few indicative pottery sherds that were found in the foundation trench all date to IA II, but can not be dated with more precision. The wall is built of large dressed stones. We were able to follow the wall eastward to a distance of 8.5 meters until it disappeared below a modern paved road. Aharoni reconstructed a second outer wall running parallel to our wall and three inner partition walls. We cannot confirm these observations because if the parallel wall did continue eastward, then it is located below the modern road. It must be pointed out that we found no partition walls. A well-made thick floor consisting of white crushed local soft chalk rock was found above the Iron Age wall and was attributed to level D2-3. The floor was exposed in almost the entire area of excavation. Its thickness varies between 20 and 40 cm and is therefore very distinctive. This had made the floor into a stratigraphic base point serving to differentiate between features that the floor covers, features that coexist with the floor and those that cut through the floor. While the floor's relative chronology was easy to determine, its absolute date is debatable. In most cases the soil below the floor did not produce any dateable finds. The only well-dated feature found sealed below the floor is

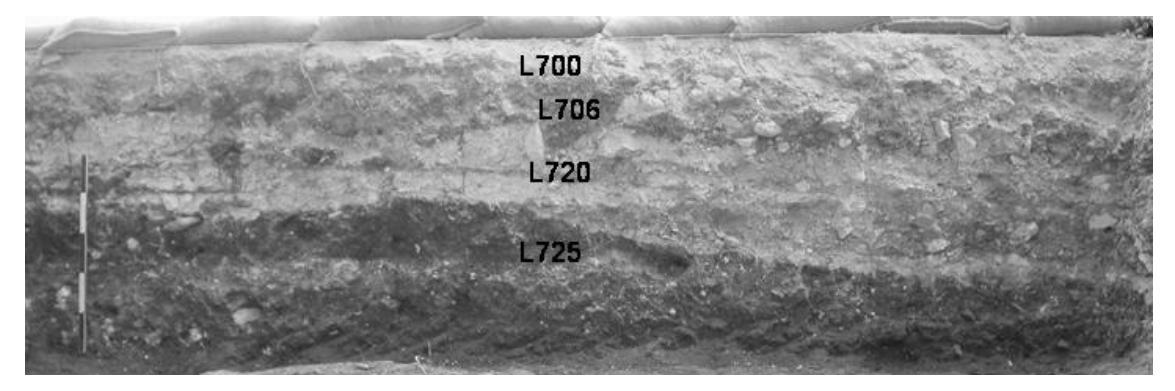
#### Fig. 5 - Section through Iron Age Floor in Area D3

The result of our section into the courtyard's floor confirms the observations made by Aharoni. The floor itself was made of crushed lime. Its thickness varies and measures as much as 30 cm. below the floor we found a fill of soil lying above the natural rock. Apparently the natural rock slopes here from southwest to northeast. The fill and the floor varying thickness leveled the natural slope and created a horizontal surface. Pottery dating to the later parts of the Iron Age was found in and below the floor. It is important to note that only one Iron Age stage was found and the pottery in and under the floor was of the same type. In this area of the Iron Age palace we found no clues for an earlier 8<sup>th</sup> century BCE stratum (Aharoni's Stratum VB). Similar results were obtained in a section through the court made by us in the 2007 season at the southern edge of the court. Here too we found the thick white chalk floor and below it layers of earth fill.

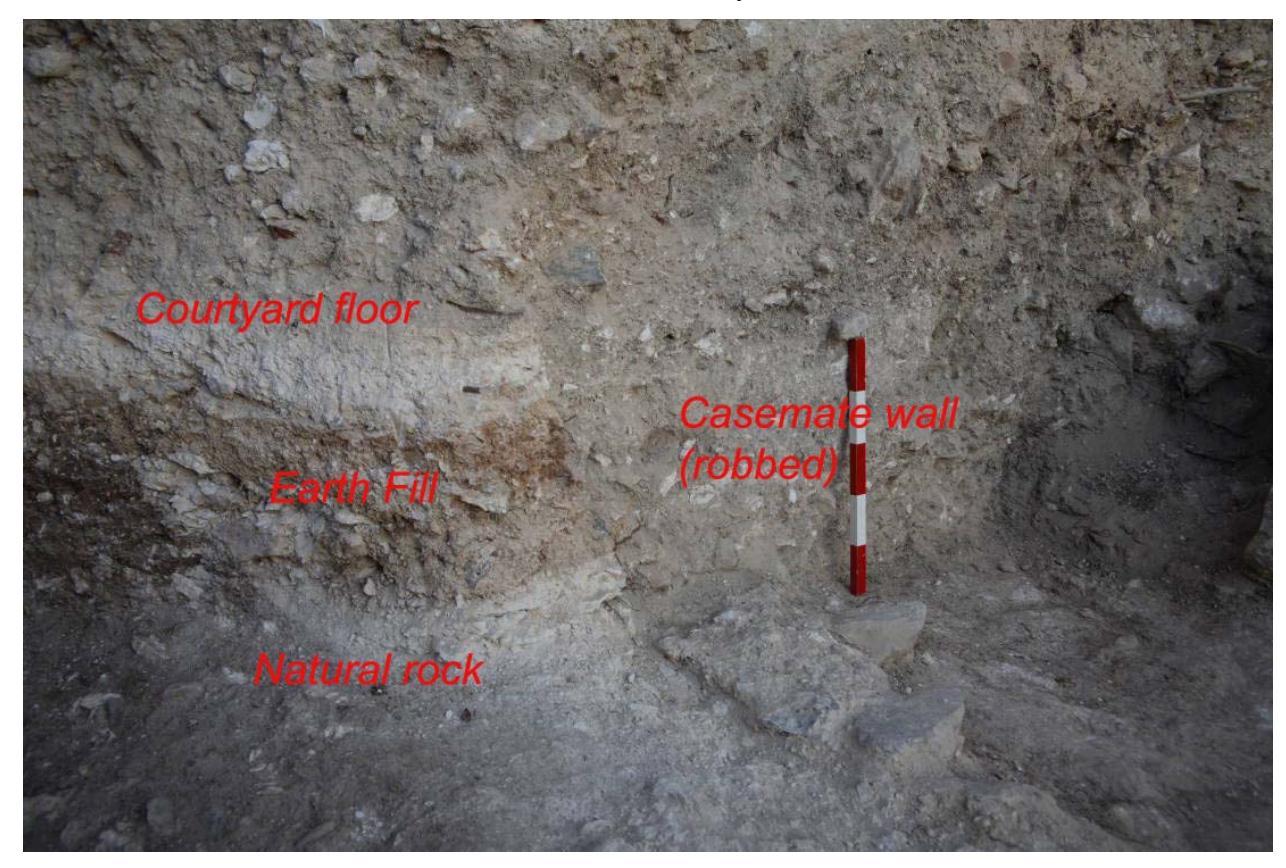
Fig. 6 - Section in Courtyard, 2007

A second section was cut south of the 'inner gate' and just by the stone pavement interpreted by Aharoni as the pavement of the inner gate. Here we found a line of white chalky floor, similar to that of the courtyard described above. The floor is most certainly located below the stone pavement of the 'inner gate'. Due to the very limited exposure here it is not possible to determine at this point whether the chalk floor is indeed the same as the courtyards floor. If further excavations here will prove this assumption, then the stone pavement will have to be to be assigned to a later stratigraphic stage and the notion of an 'inner gate' will have to be reevaluated.

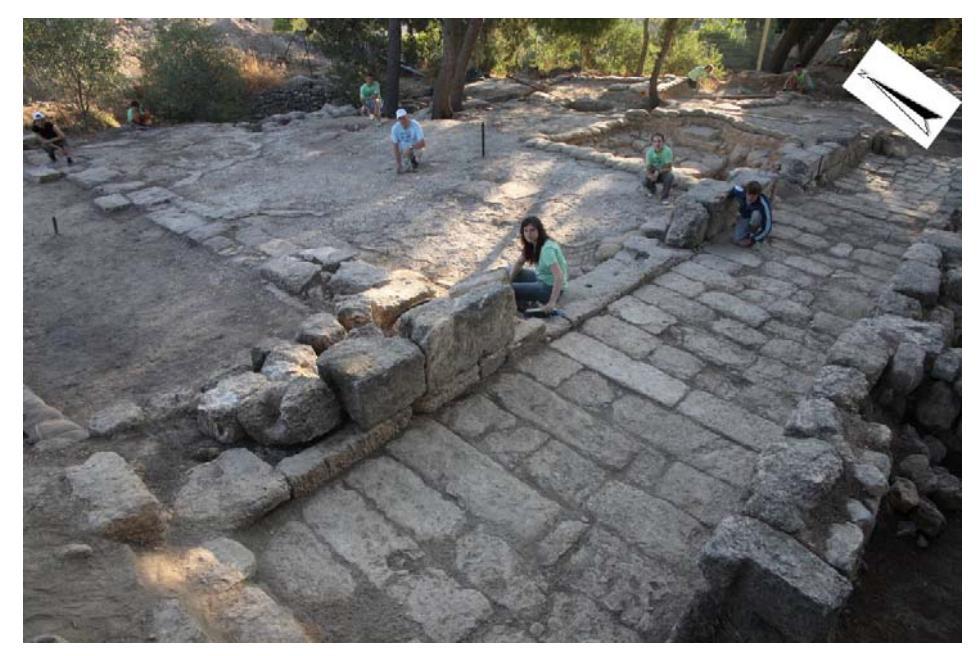
Fig. 7 - the church (Area D4)

We had re-exposed the walls of the Apse and the walls of 'room 3' at the front of the church (Testini 1964: 103 and Fig. 39). Two small sections were made in places were only the mortar of the mosaic floor was preserved in order to collect coins and other datable material from the foundation of the church. This material is still being processed and will be reported upon in future publications.

To the earliest phase we assigned two large pressing installations made of at least four plastered vats and a two extended pressing floors. The vats and the floors were sealed by the mortar of the mosaic floor of the church and are therefore earlier. Walls found below the church's floor indicate that the pressing installation was located inside a built insula, but the exact plan of this building is yet to be understood.

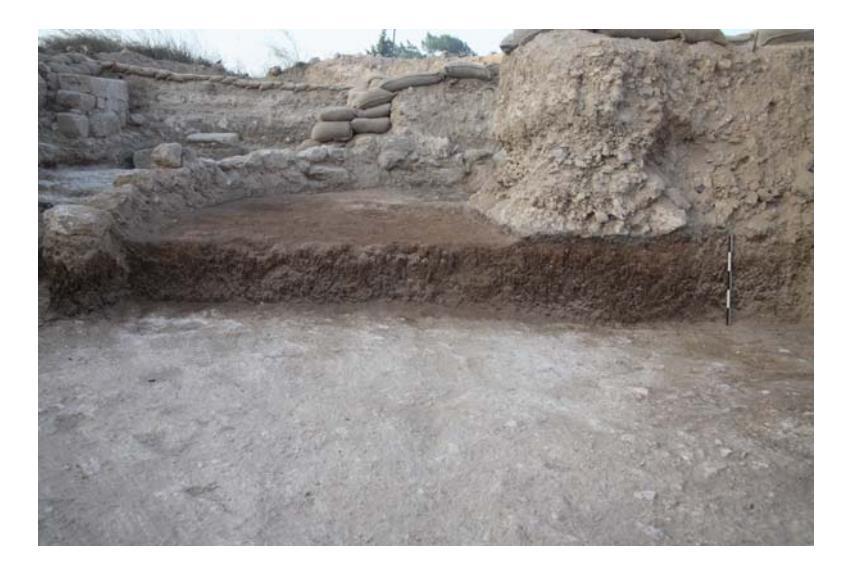
Fig. 10 - The garden soil and the flattened bedrock

On this surface a layer of chocolate-like colored earth, interpreted by us as 'garden soil,' was laid. This soil is not the natural soil of the site and had to been brought from somewhere else – probably the valley of Rephaim to the west of Ramat Rahel. Wherever the dark garden soil was exposed it was always around 40 cm thick and laying upon the flattened bedrock. It has to be noted here that in the 2005 season we had came across similar flattened bedrock surface coated by 'garden soil' in our areas A and B, both

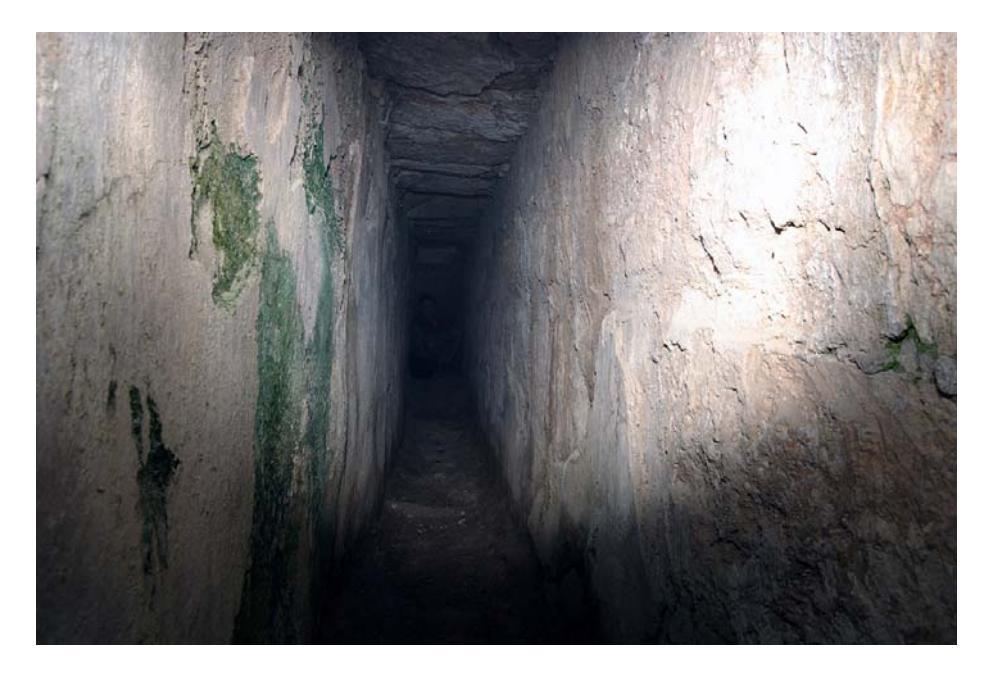
Fig. 11 – A Picture inside Tunnel A

*Rock-cut tunnels*: In 2006 we found the continuation of 'Tunnel A', cleaned already in 2005. The tunnel was first cut into the flattened bedrock and then its side walls were built by stones and plastered. Large rectangular cover stones were used to roof the tunnel. Previously we reported that the tunnel is made of two sections: the first section is 9.2 meters long in an east west direction. In its western end, the tunnel makes 90 degrees turn to the north and continues for 4 meters more until it ends with a built and plastered wall.

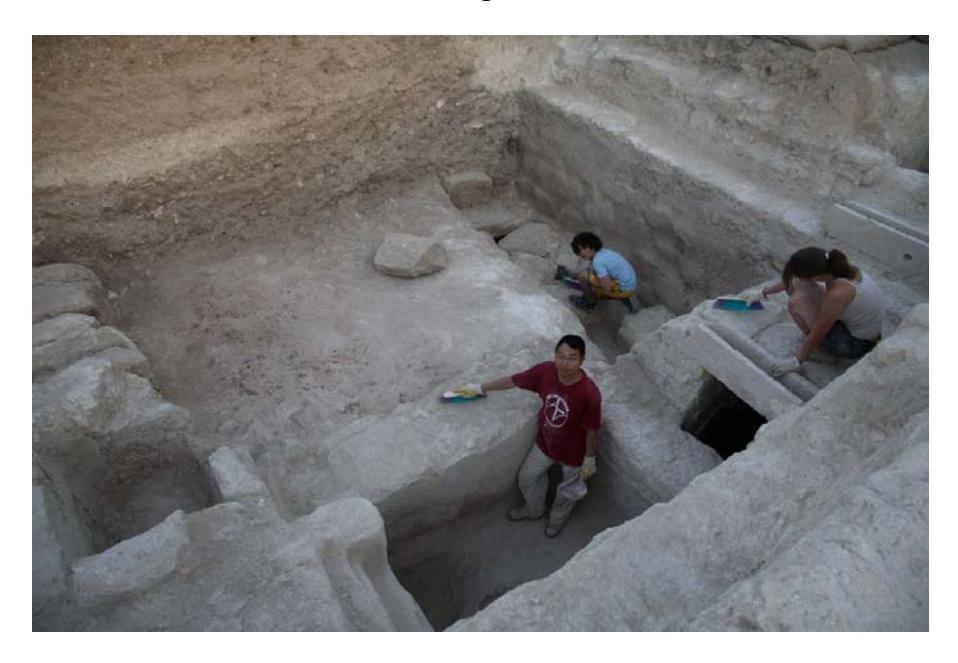
Fig 12 the drains and the and the Area West of Pool 2

The destination of the two drains is still obscure and its understanding is depended on the understanding the most puzzling part of the enclosure: the area west of pool 2 (see figures 12 and 14). Here we uncovered a wall built onto the northern scarp. The wall is plastered. To the south of the wall there is ditch, around a meter thick curved out of the rock. At the base of the ditch we discovered large flat stones, similar in shape to the foundation stones of pool 2. South of the ditch, the flattened bedrock (this time flint rock) and two small terrace walls were exposed, one to the south and one to the west (here only a robber trench was found). The area defined by these two terrace walls and the ditch was the only area in which the 'garden soil' was missing. It seems that the two walls terraced the soil out of a 'space' the function of which can not be reconstructed. It is clear that the area went through major changes in the subsequent phases which damaged the preservation of the earlier phases. One reconstruction, admittedly hypothetical at this stage, is that the ditch was part of a plastered pool of which only the northern and eastern walls survived. The pool was built to the west of pool 2, in a lower level, and the two decorative drains (drain 2 and 3) must have served for transporting water from the upper pool 2 into this hypothetical pool to the west.

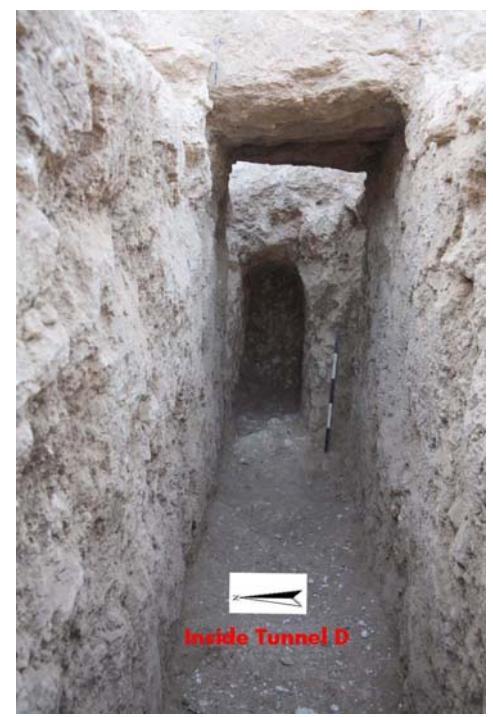
A second tunnel (Tunnel D-E, Fig. 13) was found to the south of Tunnel A-C. The newly discovered tunnel shares many similarities with Tunnel A-C but was built in a much lower quality. The tunnel (D-E) is cutting into the flattened bedrock but it side walls are built of stones. Only a few cover stones were left from the many that once roofed the tunnel. Section D of the tunnel is oriented east-west and is 3.25 meters long, starting from the eastern scarp. It makes a turn southward and then continues for close to fifteen meters, until it reaches the southern scarp (section E). Here too, the tunnel

does not lead into a reservoir or other kind of destination. We are still unable to understand where exactly the source of the water is and what the purpose of the rock-cut tunnels was. This tunnel connects the eastern and the southern scraps, and it seems that both tunnels were made in order to hold the water and not to transfer them to any other place.

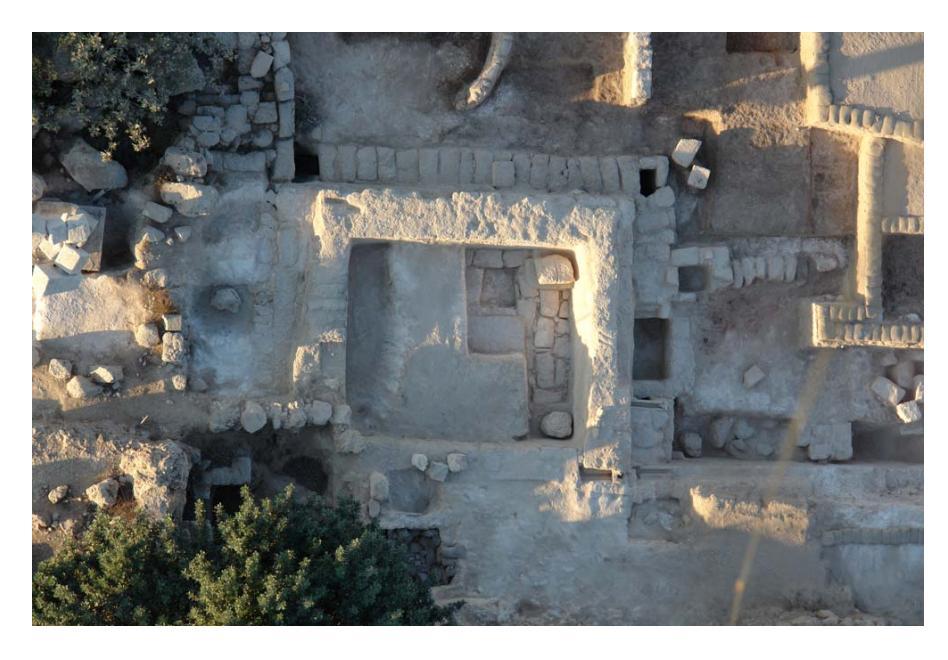
Fig. 14 – Aerial View of Pool 2

We continued to clean the earth-fill from within the pool. The finds from this fill are connected to later usage of the pool and will be elaborated later (below, phases C1-3). We had now uncovered the four corners of the pool (including the relocation of Ran Morin statue that was placed on the south-western corner of the pool). The inner size of the pool is 7X7 meters. The north scarp of the enclosure serves as the northern wall of the pool. Although the natural rock could have served as the northern and eastern walls of the pool, stones were laid against the face of the rock in order to coat it and create a

reinforcing wall. The other two walls were also built of stones. Thick plaster layers were found on both the inner and outer faces of all walls. We made a section into and below the pool's floor. It turned out that for the creation of the pool the natural rock was hewn (like in the rest of the enclosure). Then huge thick yet flat stones were neatly laid upon the rock as a foundation for the floor. A kind of dark cement was used to bridge the gap between the stones. A layer of cement-like substance was then laid above the foundation stones. This layer was over 15 cm thick and served as the floor of the pool. Interestingly not even a single sherd or any other kind of datable material was found below the cement floor.

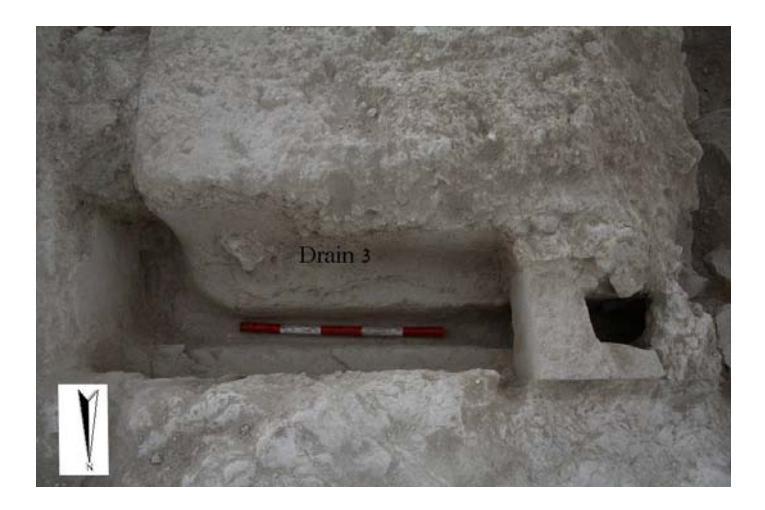
In the 2005 we found one blocked drain (Drain 2) in the southern wall of the pool. The drain carried water from pool 2 into either small pool 3 or directly into Tunnel A. in the 2006 we found two more exceptionally astatically built drains that led water from Pool 2 westward. Drain 3 begins as a small rock-cut tunnel in the north western corner of the pool, just below the surface of the pool (Fig. 15).

The tunnel makes a curve westward and then by an elegantly shaped step continues upon the built wall that coats the northern scarp. The later parts of the drain are built by thin worked stones in a very high-quality fashion. Drain 4 is built in the same manner, about a meters south of drain 3 and 50 centimeters below the surface of the pool. It starts inside the western wall of pool 2 and continues westward passing above built tunnel C. It should be noted that both these drains were found blocked by layers of plaster which means they went out of use when in the last days the pool was in use (phase D1-3 below).

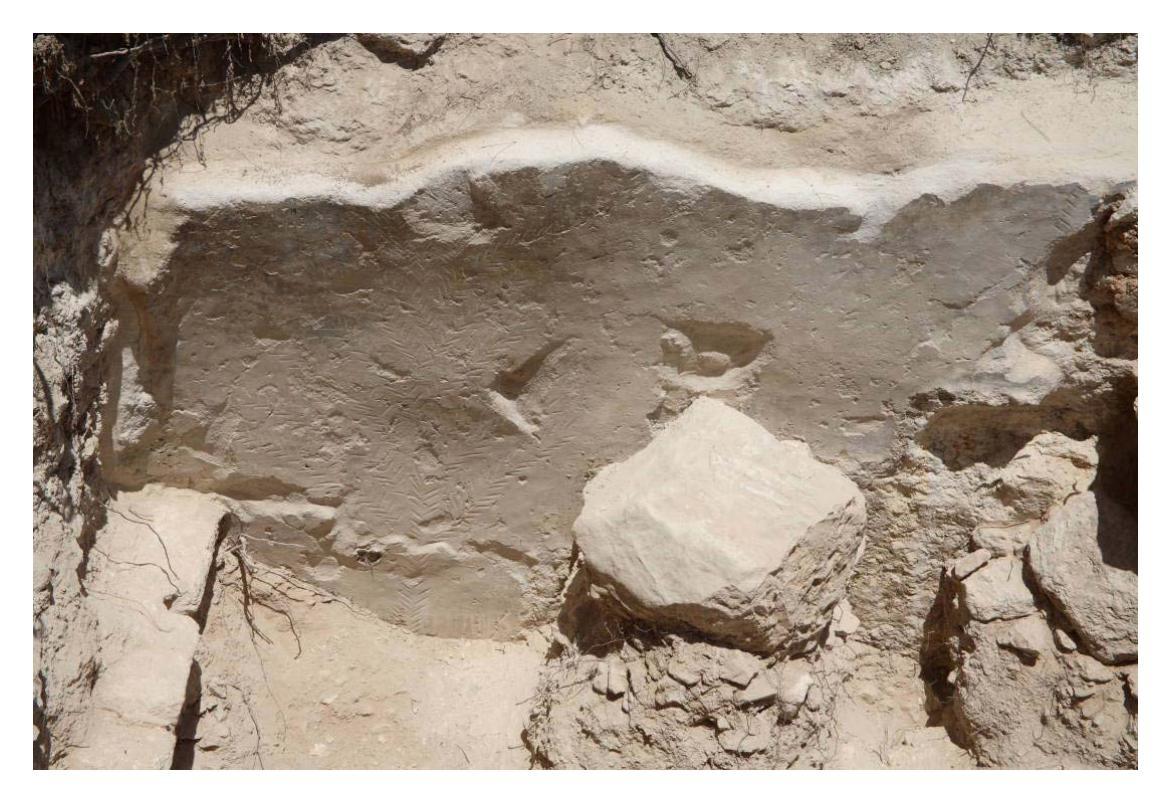
Fig. 16 - The Decorated Plaster in the Ritual Bath

Apart for cleaning the previously exposed Iron Age architecture, we also dug a huge subterranean space that was cut into the natural rock, located just east of the above described wall. The space was originally cut for a Jewish ritual bath ('mikveh'). The rock-cut walls of the bath were coated with decorated plaster with a unique tree-like design. A line of steps led down into the bath. In a later stage, dating by an abundant number of finds to the Byzantine period, the steps were curved out and the space was covered by vault roof. Aharoni reported finding similar vaulted subterranean spaces at other parts of the site (for example Aharoni 1964: 14).

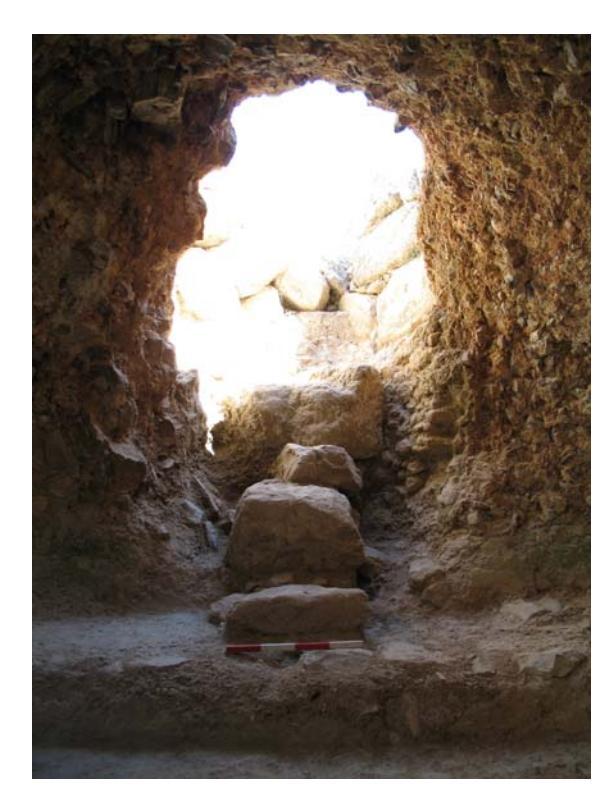
The ritual bath excavated is shaped as a stepped subterranean rectangular cave (Fig. 17), measuring c. 3X2 m. It contains 3 wide steps, and a slightly wider bottom. The original hewn passage leading into the ritual bath is sealed by later debris, in which few steps were shaped, probably in order to use the space in a later period. While cleaning the accumulation found inside, it became clear that the ritual bath was open in the last decades, since beer bottles and bags were found at the bottom of the accumulation and below large fallen stones. It seems that it was cleaned by one of the former expeditions to the site, or in another unknown occasion. In any case, the ritual bath is now cleared

down to its bottom, and constitutes another nearly complete example, and seventh in number in Ramat Rahel, of this typical Second Temple Period Jewish ritual bath. It thus helps to estimate the perimeter of the settlement in this period, a relatively underrepresented time-span in the above-ground architecture of Ramat Rahel.

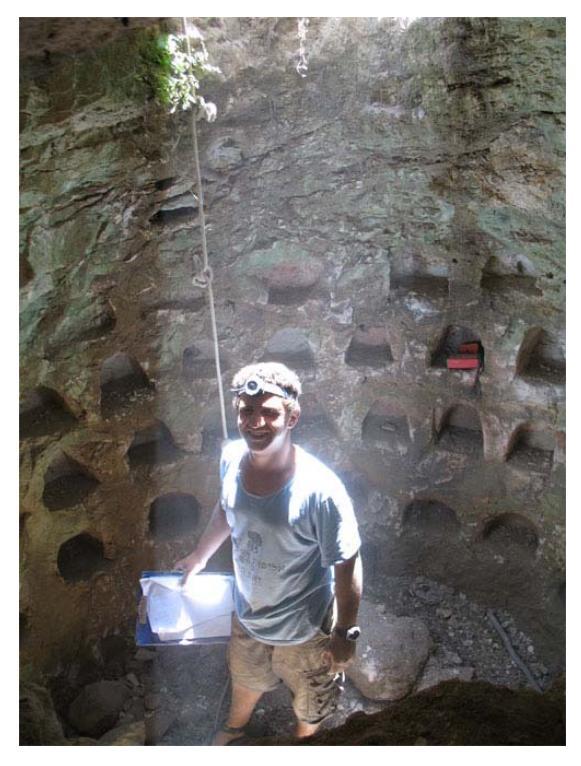
The excavation in the columbarium (Fig. 18) resulted with the appreciation that the subterranean complex is much more elaborate than previously known. At least two ancient entry-ways into the complex were found, one of them thought to be an opening into a different cave in the preliminary survey. Two more chambers which contain columbarium niches were found, as well as additional two dividing walls within the subterranean zone. From a relative chronology point of view, we can define at least five different phases. Nevertheless, regarding the absolute dating

of the various elements and phases, nothing can be stated with certainty except for the accumulation inside chambers D and E after they went out of use. Though the pottery assemblages still demand further study, it is safe to determine that the columbarium complex functioned before the Late Roman period and possibly even before the end of the Second Temple period, since pottery, stone vessels and glass objects dating to the latter periods are found in the above-mentioned accumulation. The ancient hewing (chamber F) found below chamber A of the complex should be dated to the Hellenistic period, if not earlier.
